# Manhole Inspection Summary

Manhole # S15YY\_017MH

Insp Date: **3/22/07 10:12 AM**

**Location** Address: **2704 HILLDALE AVE**

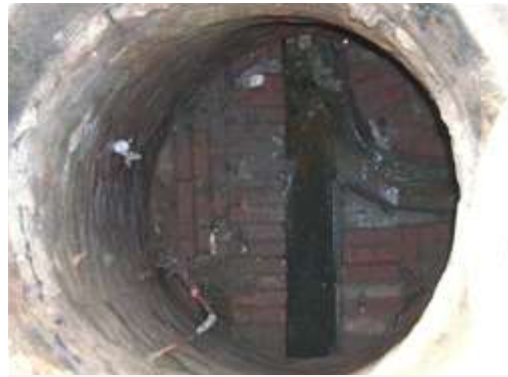
Top View

Evidence of surcharge - Bench debris. Channel debris. Corroded and missing steps.

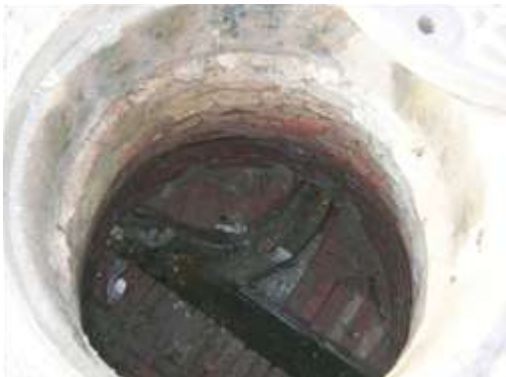
Defect

Frame leaks. Adjustment and Corbel deterioration and infiltration. Barrel infiltration.

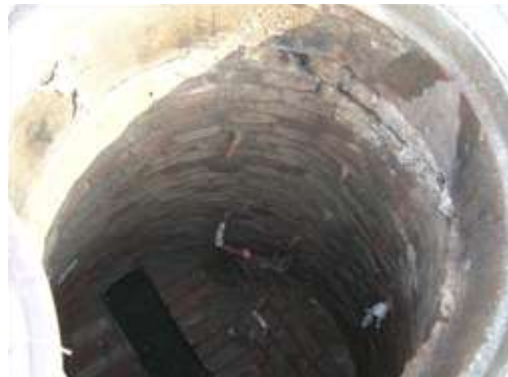
Defect

Frame leaks. Adjustment and Corbel deterioration and infiltration. Barrel infiltration - other side.

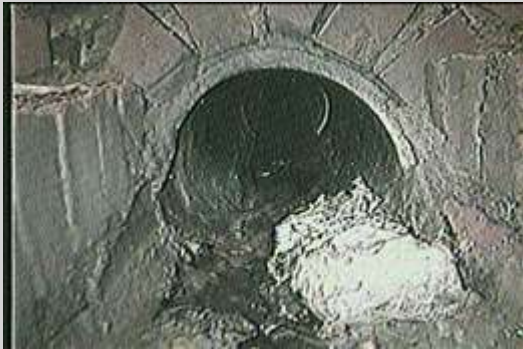
### 8 in. Circular Gravity Sewer Pipe Out @ 12 O'Clock

Deposits: ☐ None ☒ **Mud** ☐ Sludge ☒ **Debris** ☐ Grease

Infiltration: **Evidence** Pipe Seal Cond: **Unknown**

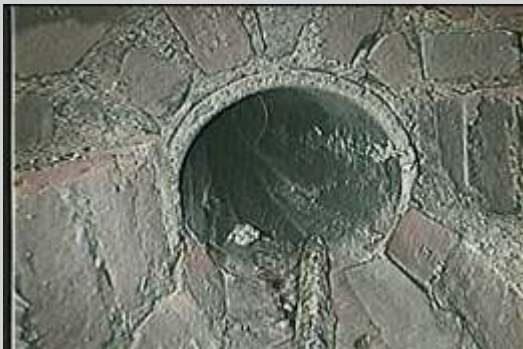
### 8 in. Circular Gravity Sewer Pipe In @ 3 O'Clock

Deposits: ☐ None ☐ Mud ☐ Sludge ☐ Debris ☒ **Grease**

Infiltration: **Evidence** Pipe Seal Cond: **Cracked**

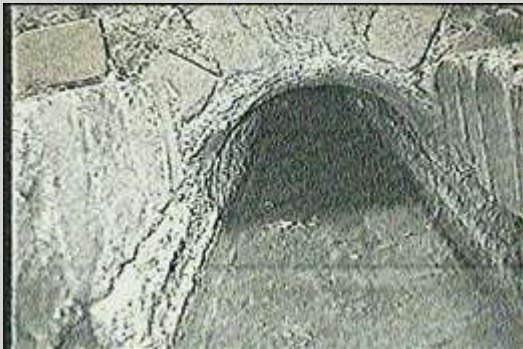
8 in. Circular Gravity Sewer  
Pipe In @ 6 O'Clock

Deposits: ☐ None ☐ Mud ☐ Sludge ☐ Debris ☒ **Grease**
